# SERVICE BULLETIN

500 #2  
7/22/71

## OIL PUMP SERVICING PRECAUTION

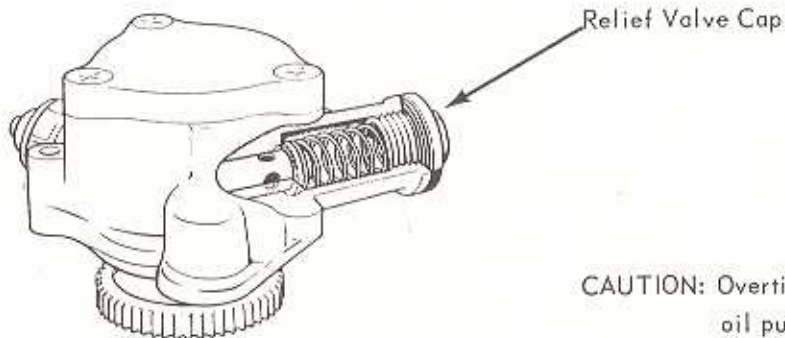
After servicing the CB-500 oil pump, use extreme care during installation of the oil pressure relief valve cap, Part Number 15331-323-003, to avoid overtightening the cap.

CAUTION: Overtightening may fracture oil pump cap.

Correct oil pressure valve cap tightening torque is 7.2-10 ft.lbs. (1.0-1.4 Kg.m.).
