550 #7
3/24/76

SERVICE BULLETIN

SOFT MOUNTING CUSHIONS IMPROVE INSTRUMENT ACCURACY

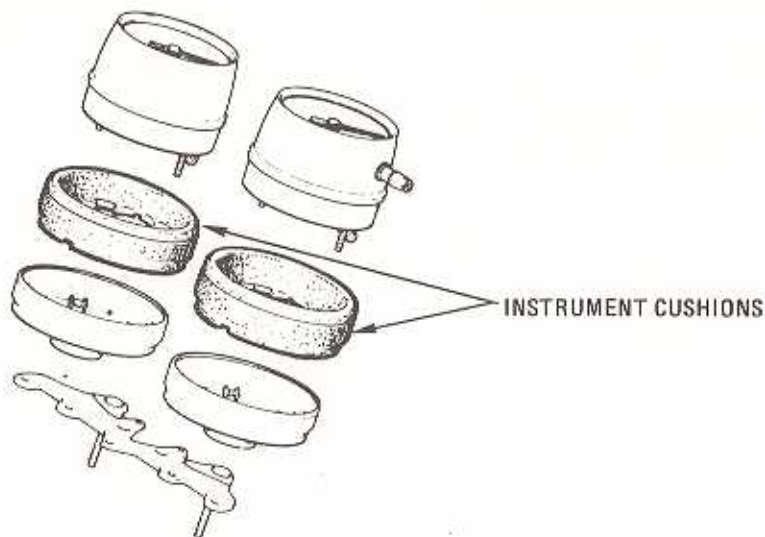
Instrument inaccuracy or needle fluctuation is frequently caused by vibration transmitted through the instrument mounting and does not necessarily involve any defect in the instrument itself.

Softer material is now used in instrument mounting cushions. Soft cushion material causes less vibration to be transmitted to the instruments.

When you encounter an inaccurate or fluctuating speedometer or tachometer on a CB-550 model not equipped with soft instrument cushions, you may be able to correct the problem by simply installing new cushions.

Do not attempt to correct instrument inaccuracy or needle fluctuation by replacing the instrument, unless the problem persists after soft instrument cushions have been installed.
