SERVICE BULLETIN

AMERICAN HONDA MOTOR CO., INC. MOTORCYCLE SERVICE DEPARTMENT

1980 CB650 ACCELERATION PERFORMANCE

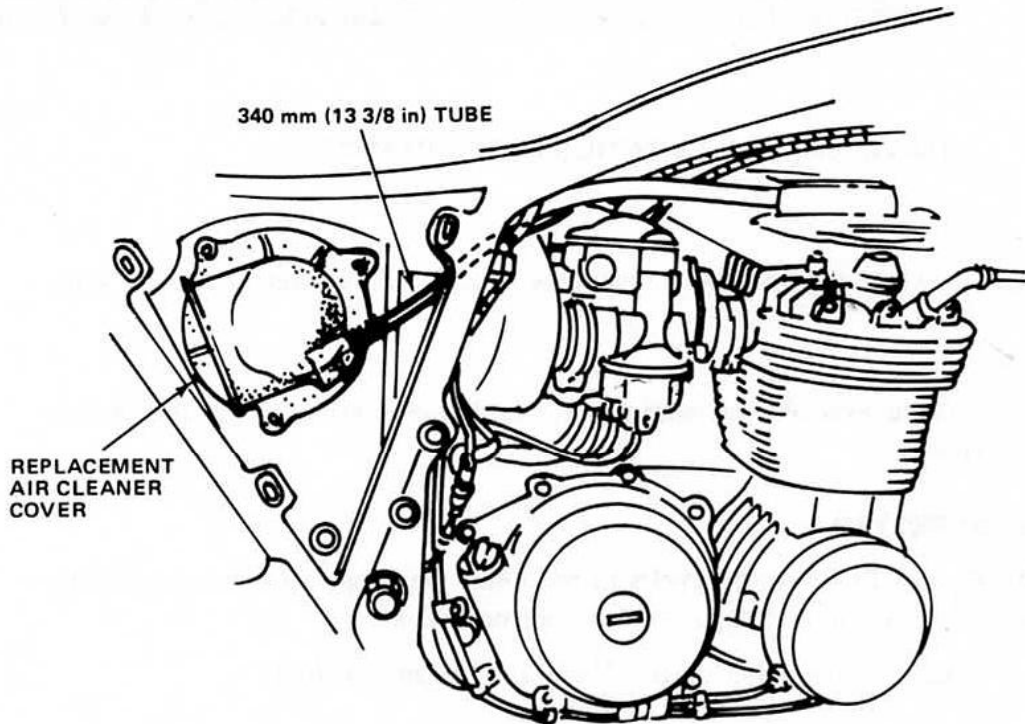
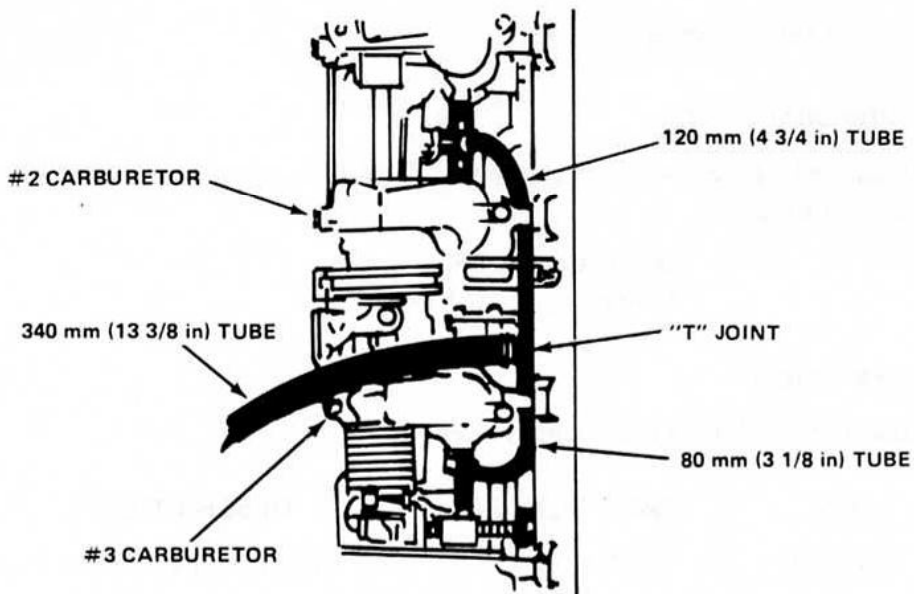
AIR CLEANER COVER SET INSTALLATION AND ROUTING

Poor initial response when the throttle is suddenly opened while running at high rpm.

Rich fuel mixture due to excessive pressure differential between each venturi and externally vented float chamber.

If the customer experiences this acceleration performance problem, install air cleaner cover set, P/N 17225-460-670, which replaces the original float chamber vent tubes with tubes that vent the float chambers into the air cleaner case.

Route the new vent tubes as shown on page 2.
